# LAKE MARLETTE DAM RECONSTRUCTION

## September 17, 2025 Front Face Dam Nearing Final Elevation.

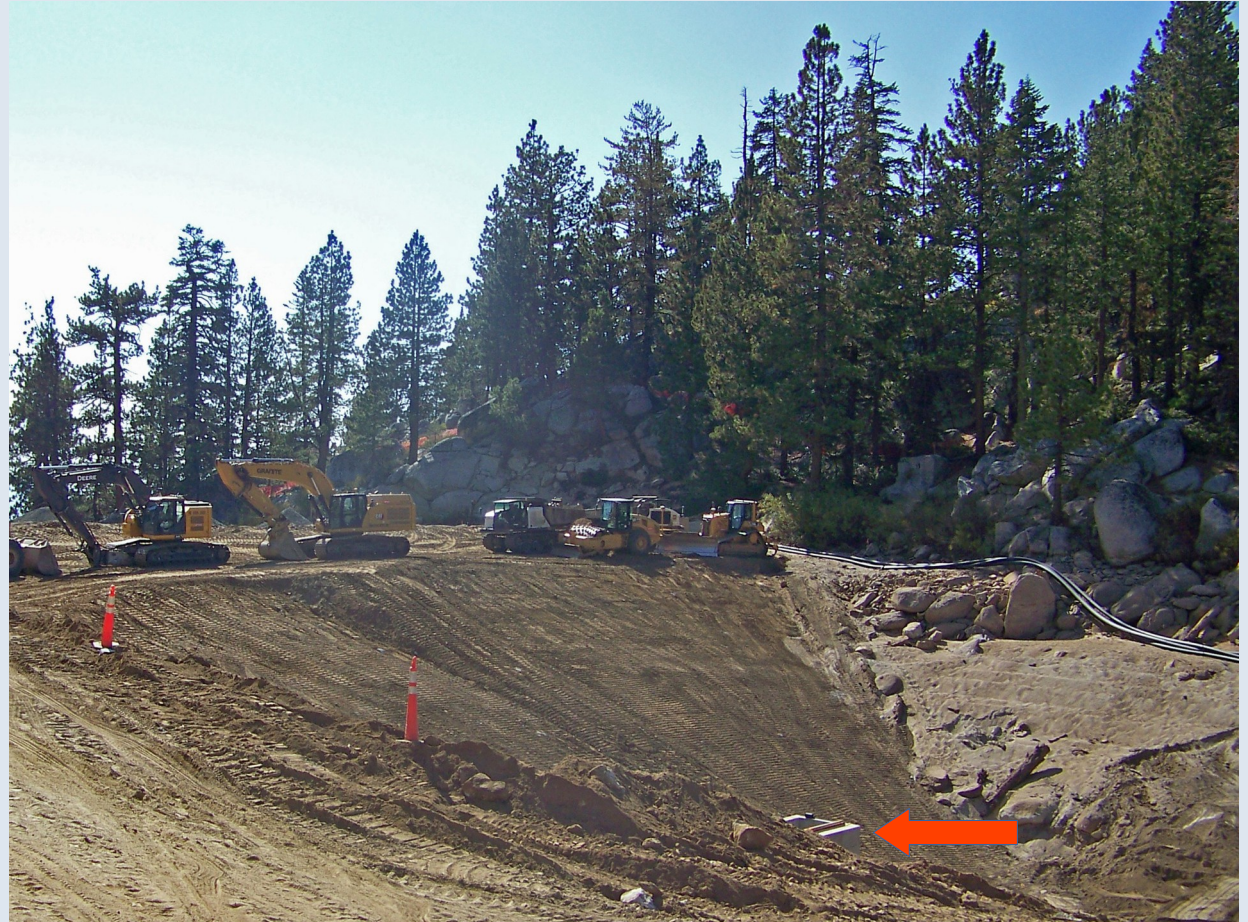
Material from the excavated dam is used in the new embankment structure roughly 16,000 yards of onsite material will be reused.

The compacted embankment is on a 3 to 1 slope.

The pipe on the right hand side was used to pump out the excavation through the emergency spillway.

The corner of the spillway intake structure is visible near the bottom of the embankment..

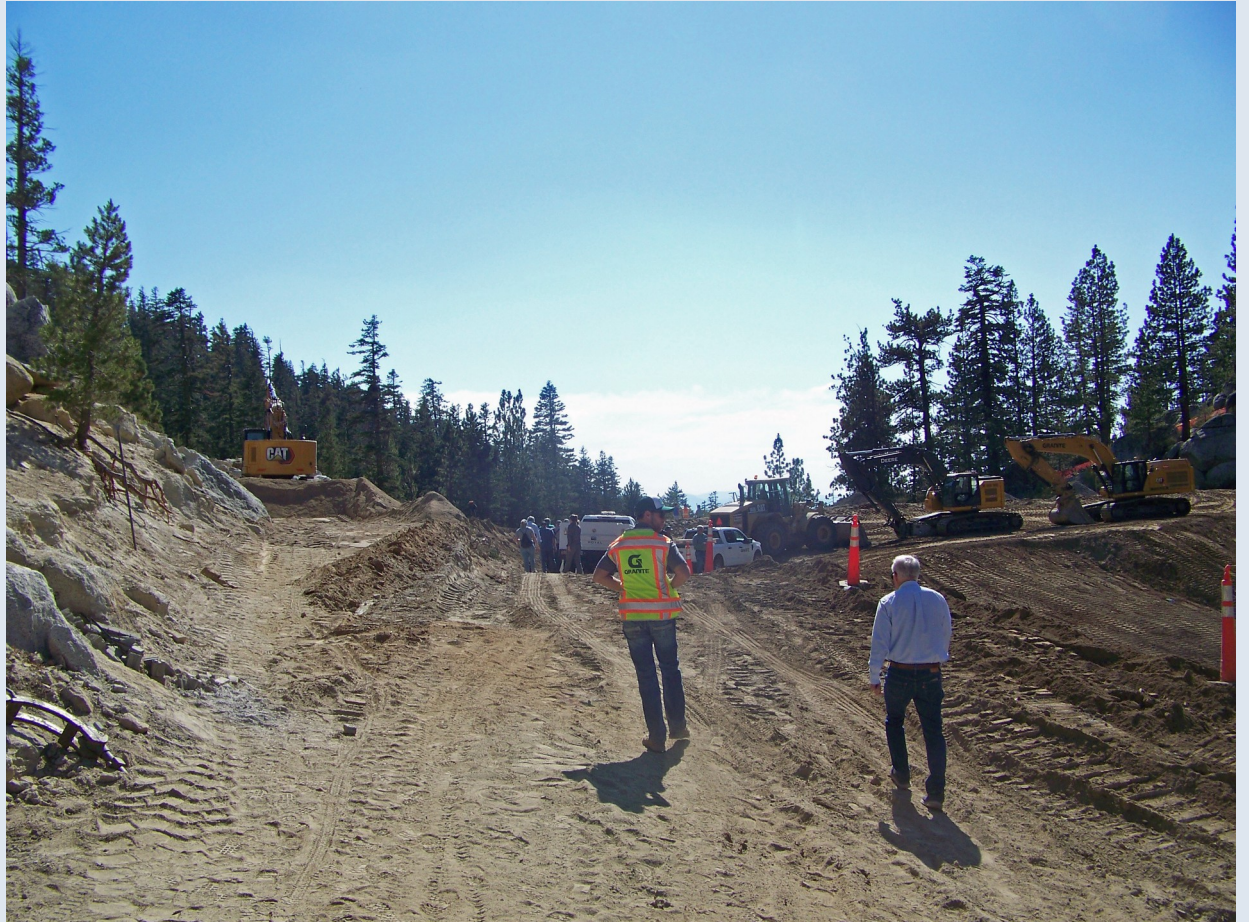
# Approaching The Current Top Of The Dam Fill At The South Abutment

Environmental constraints require that all work is completed between May and October.

The schedule is to have the new dam ready to hold water by October 15, 2025 and the cofferdam removed by November.

The average annual recharge for the lake is about 3 feet. Under normal conditions the lake will require 6 to 7 years to return to the 45 foot depth.

Work will resume in May 2026 and the project is scheduled to be completed by October 2026.

The project is on schedule.

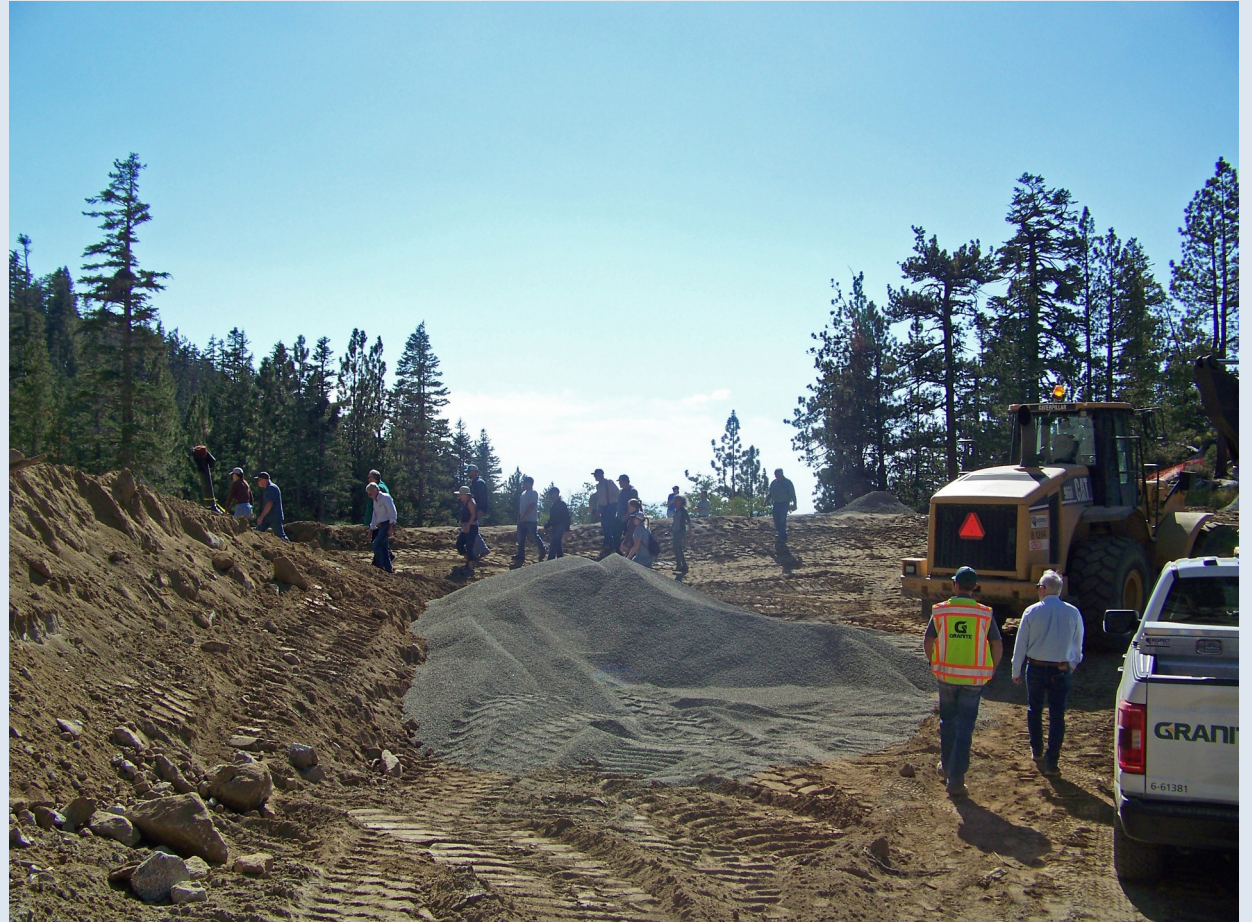
## Crossing To The Back Side Of The Dam

The back side of the dam is the buttress which anchors the dam in place.

We were requested to go to the south abutment to cross over the top of the dam.

This is a filter dam.

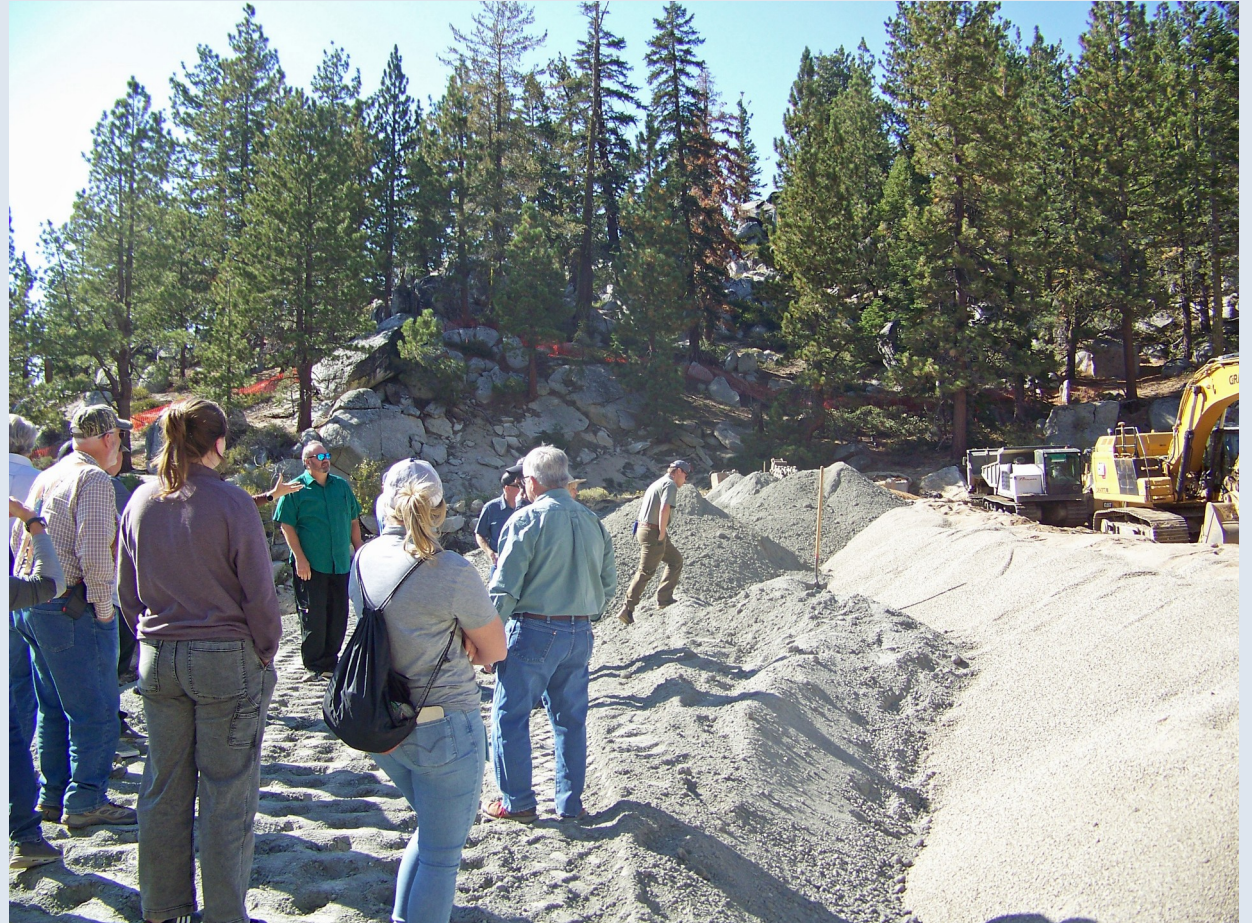
## Standing On Top Of The Buttress Filter Layer

The filter layer is designed to allow water seepage through it without erosion.

It is an engineered material from a select quarry with specific mixed particle sizes to give it the desired attribute.

We were ask to not cross over the top of the dam to avoid contaminating the filter with he front face fill material, .

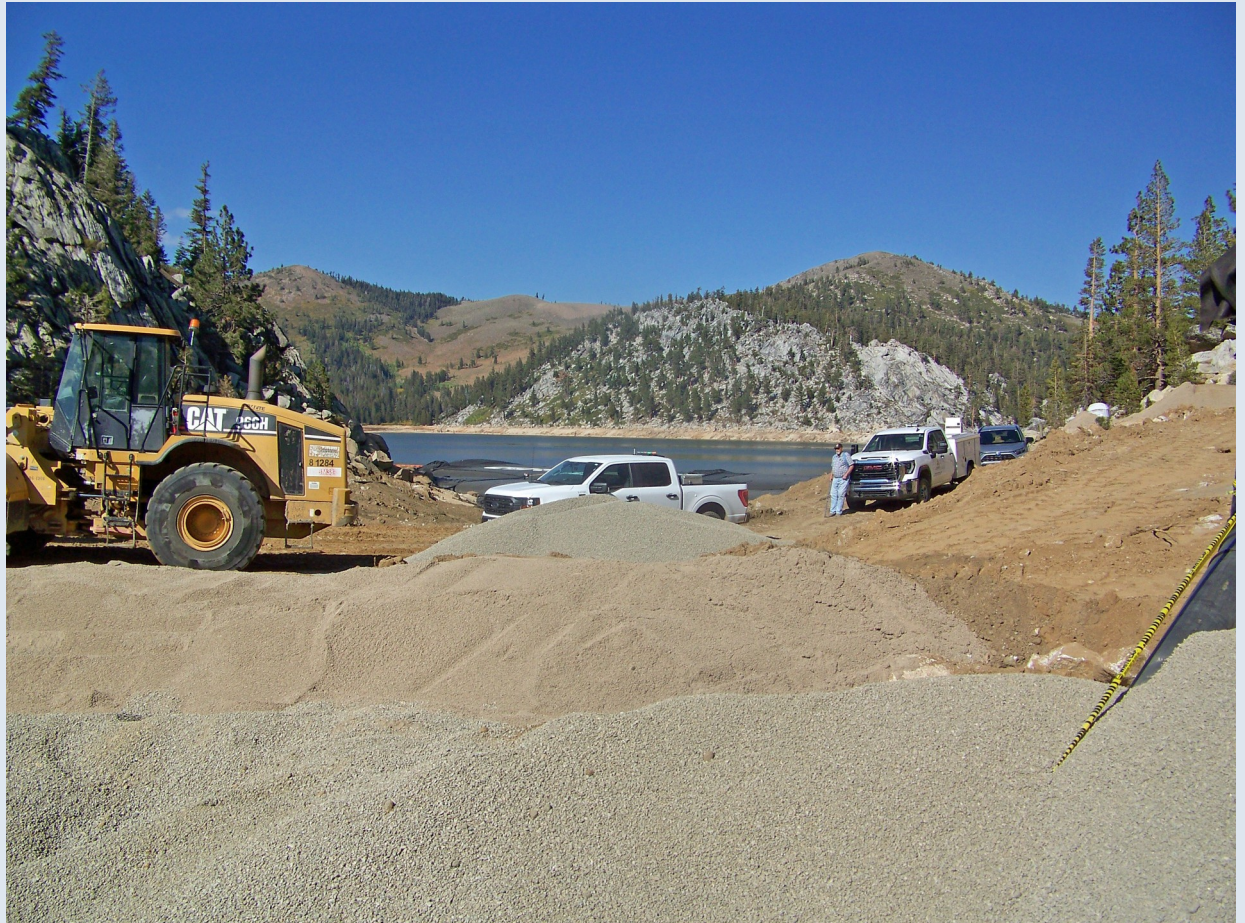
## Fill Material Versus Filter Material

The brown fill material is native soil and has a large range partical sizes.

The mixed filter material is gray and is made up relitive uniform small particles.

Imported material is hauled up the valley to in highway trucks and off loaded in Granit's staging area near Spooner Lake. It then loaded into large off highway construction trucks and transported approximately 5 miles to the dam site.

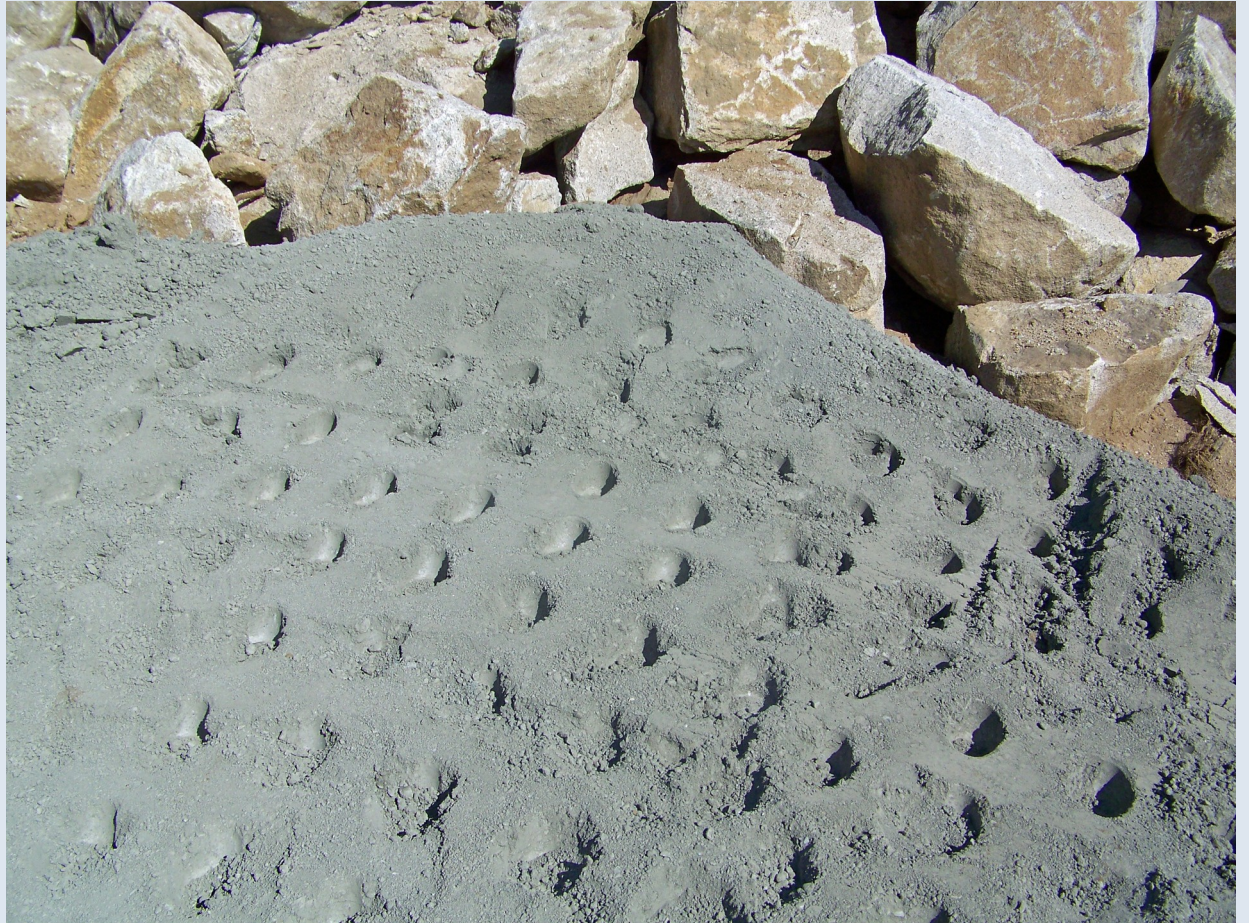
## Compacted Filter Material

Even after being walked on the compacted material holds the shape well.

The filter material looks like a fine graded concrete mix but there is not any cement in it.

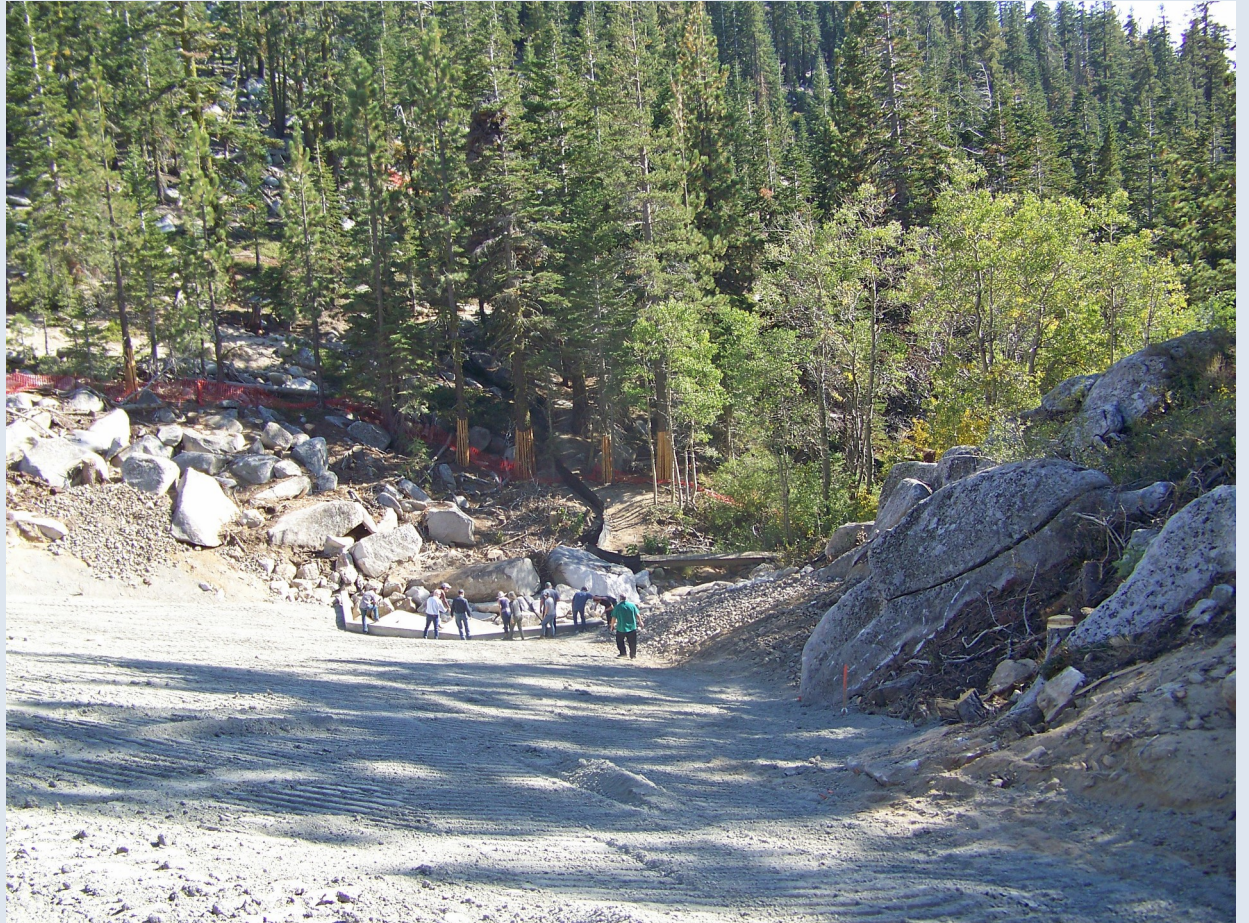
# Looking Down Butress Filter Layer To Spillway Outfall Structure From North Abutment

The concrete outfall structure is at the bottom of the dam butress.

The slope of the filter structure is steep at 2 to 1

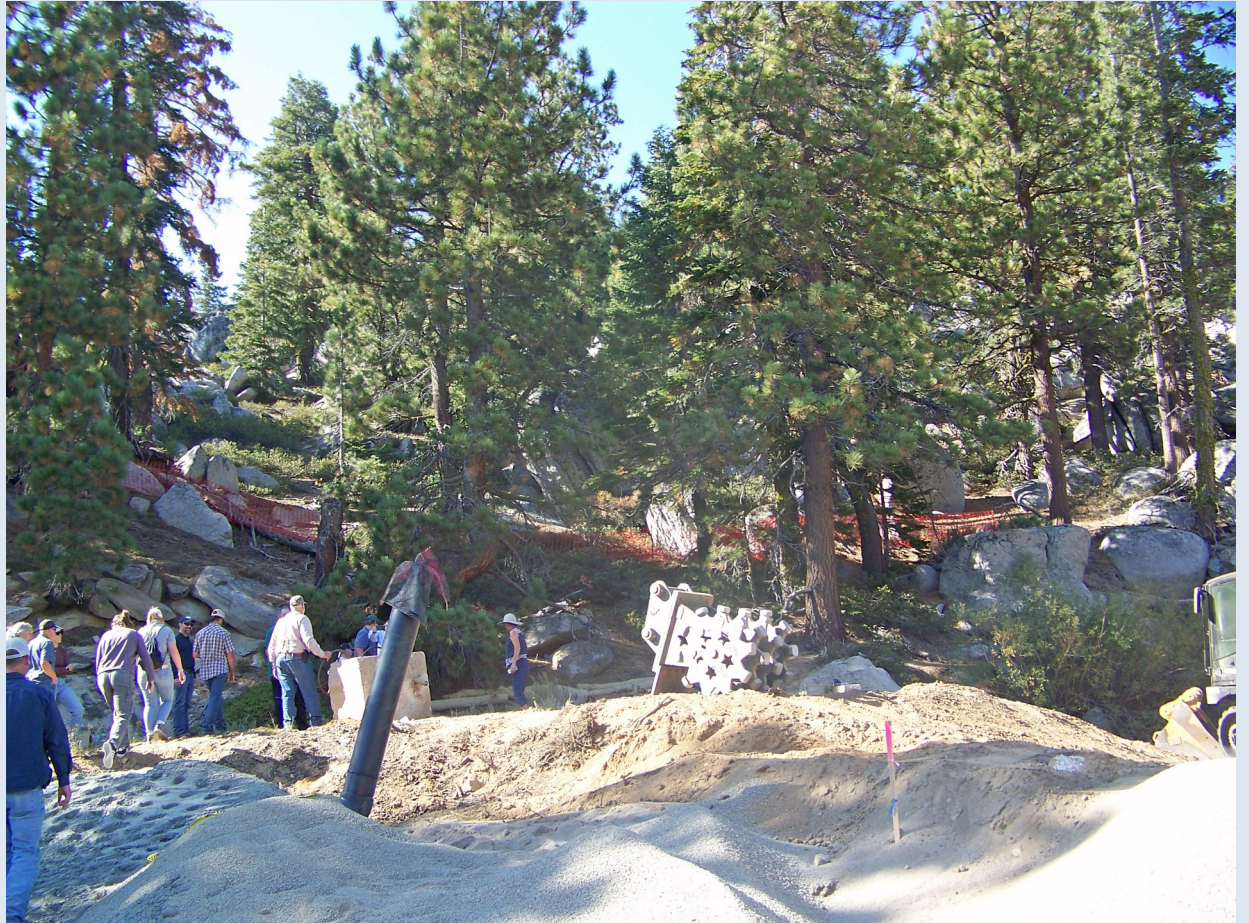
## The North Abutment

The large concrete block is the original block where the 2 hand wheels used to control the spliways are mounted.

It was located in the middle of the dam and moved here during the dam removal

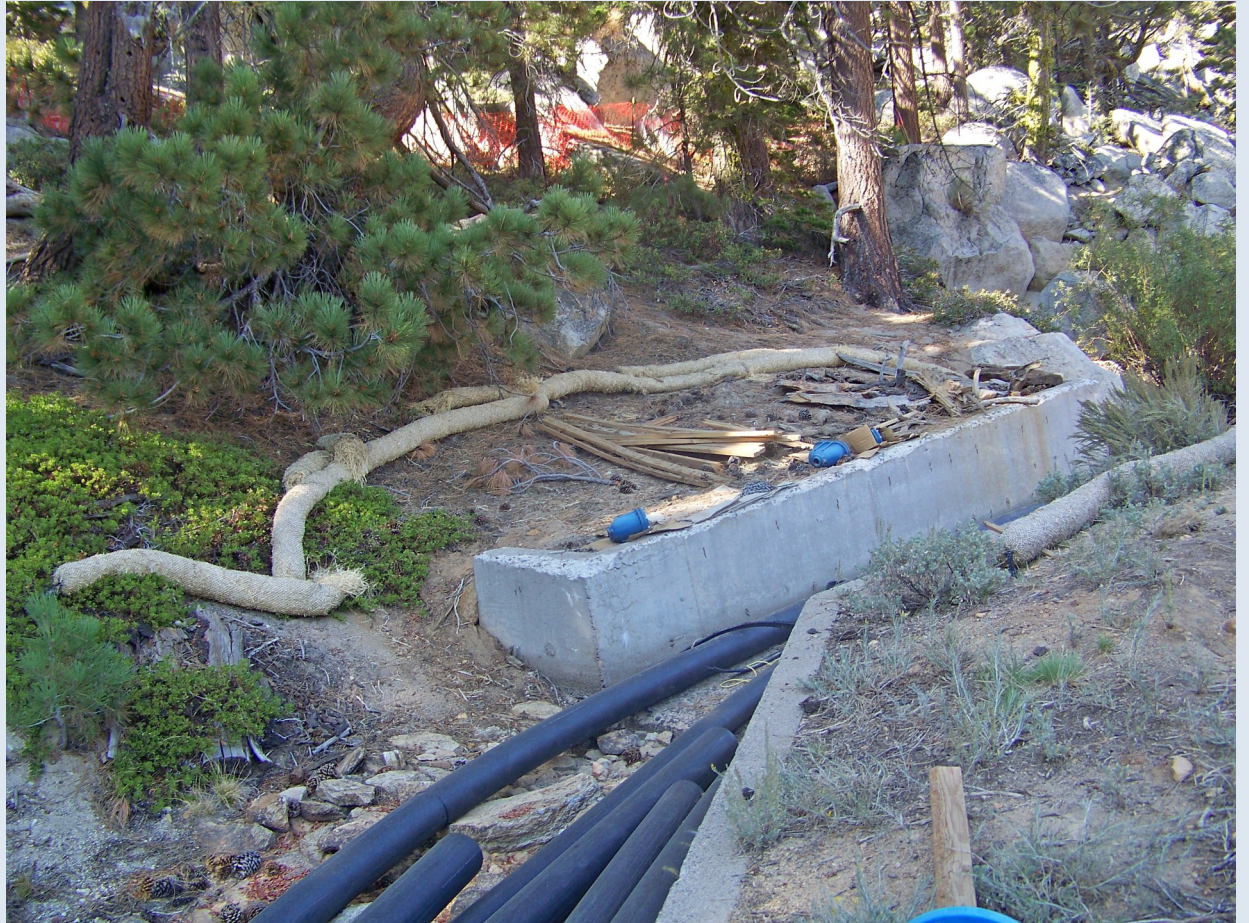
## The Original Emergency Spillway

The emergency spill way is located at the north abutment, the floor is level with the top of the dam at 45 feet.

In the winter crews have to come in by snowmobile or helicopter to shovel the snow out.

The new emergency spillway will be at the same level but it will be covered.

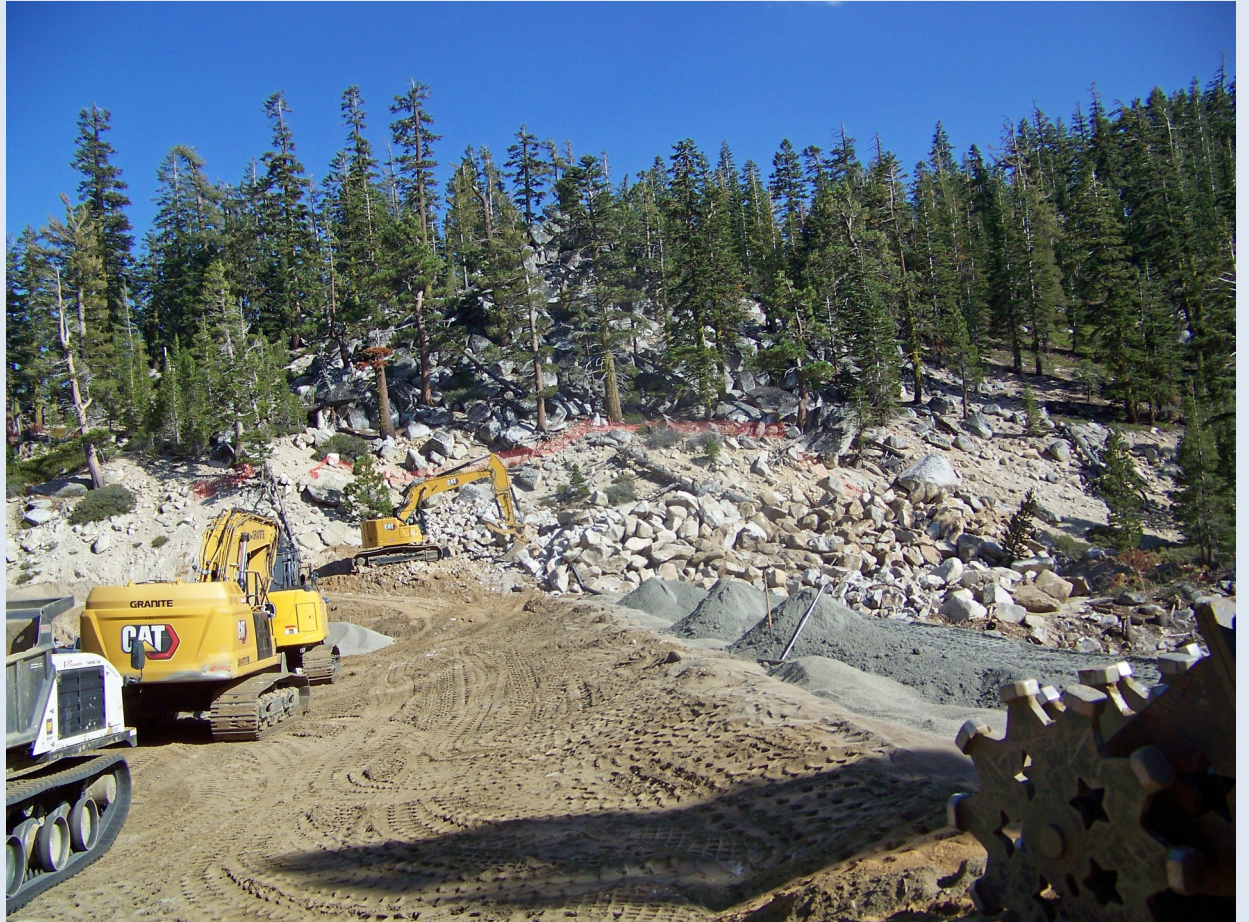
## From North Abutment

Standing on the north abutment at finished height looking across the dam at south abutment.

This gives a good idea of how close the dam it is to full height.

Filter material stored on the right to be compacted as dam face is completed.

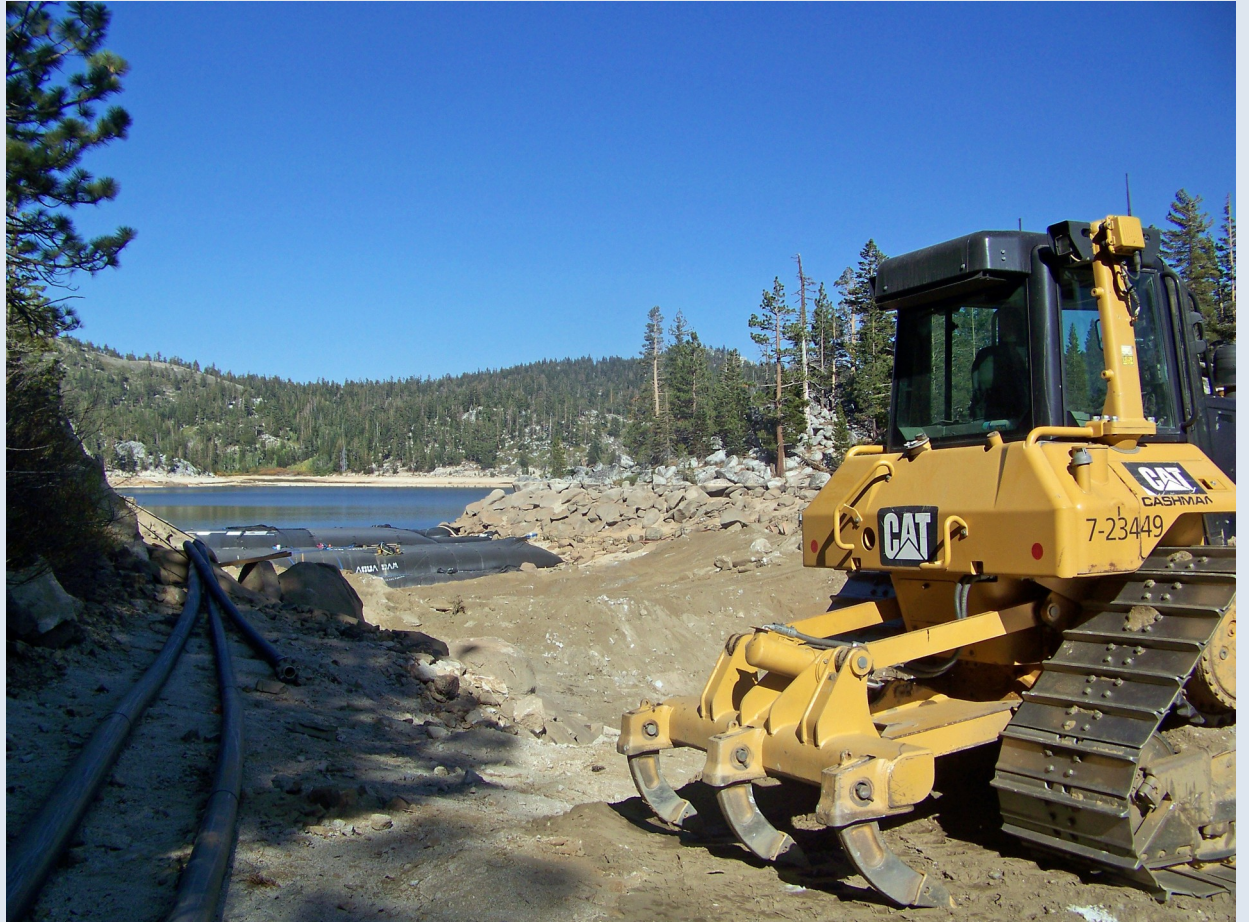
## Lake Marlette From North Abutment

The dam will be capped and the cofferdam removed before the winter shutdown.

During next years season the project will be completed including the control building and site restoration.
